# 9040: ASSESSING THE EFFECTIVENESS AND CULTURAL VALUE OF COUNTRYSIDE STEWARDSHIP HS1 AND HS8

## Final Report

Title of report	Assessing the effectiveness and cultural value of Countryside Stewardship options HS1 and HS8
Organisation	Countryside and Community Research Institute, University of Gloucestershire
Contact	Peter Gaskell (pgaskell@glos.ac.uk)
Authors	Peter Gaskell, Jeremy Lake, Rob Berry, Charlotte Chivers, Nick Lewis, Phillip White, Ken Smith, Stephen Haig, Katarina Kubinakova, Maggie Henderson
Date submitted:	July 2023
Version:	1
This report should be cited as: Gaskell, P., Lake, J., Berry, R., Chivers, C., Lewis, N., White, P., Smith, K., Haig, S., Kubinakova, K and Henderson, M. (2023) Assessing the effectiveness and cultural value of Countryside Stewardship options HS1 and HS8. Report to Defra. Defra project 9040.

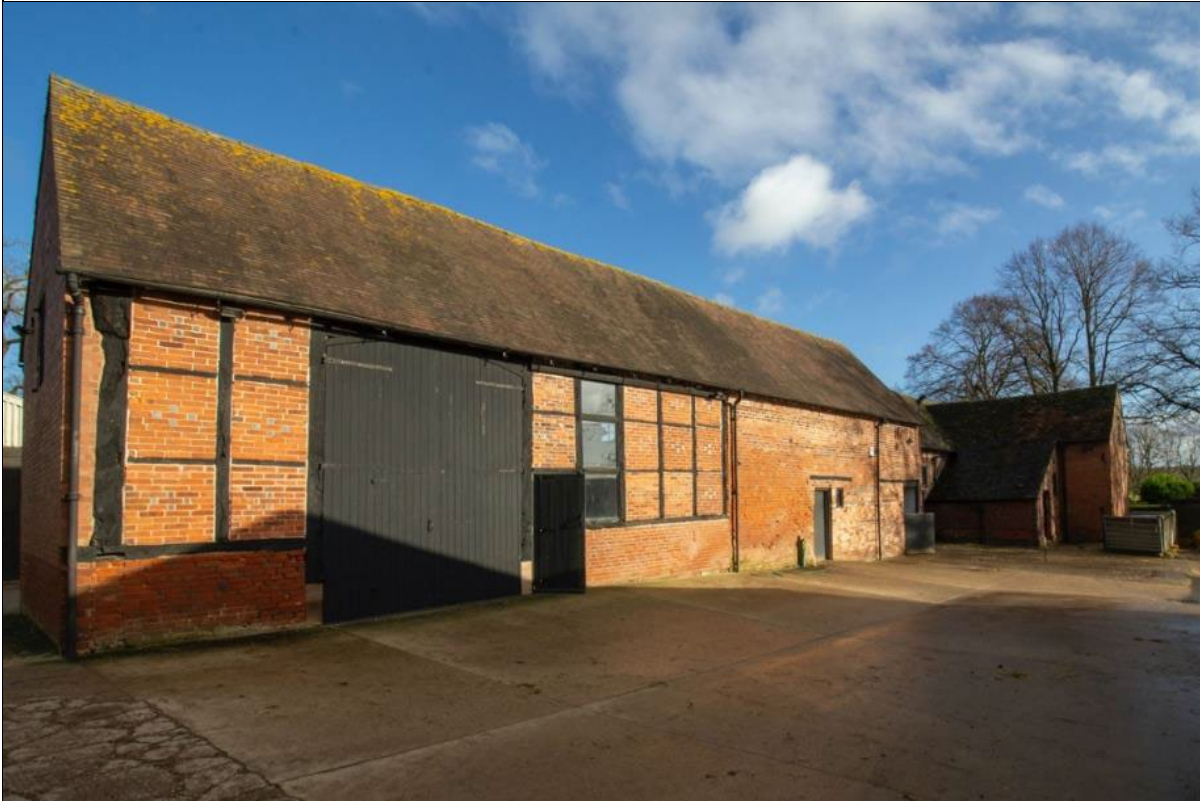
The exterior of the barn range, showing the brick infill to the exposed timber frame. Part adapted as an education centre for school children. © Peter Gaskell/CCRI

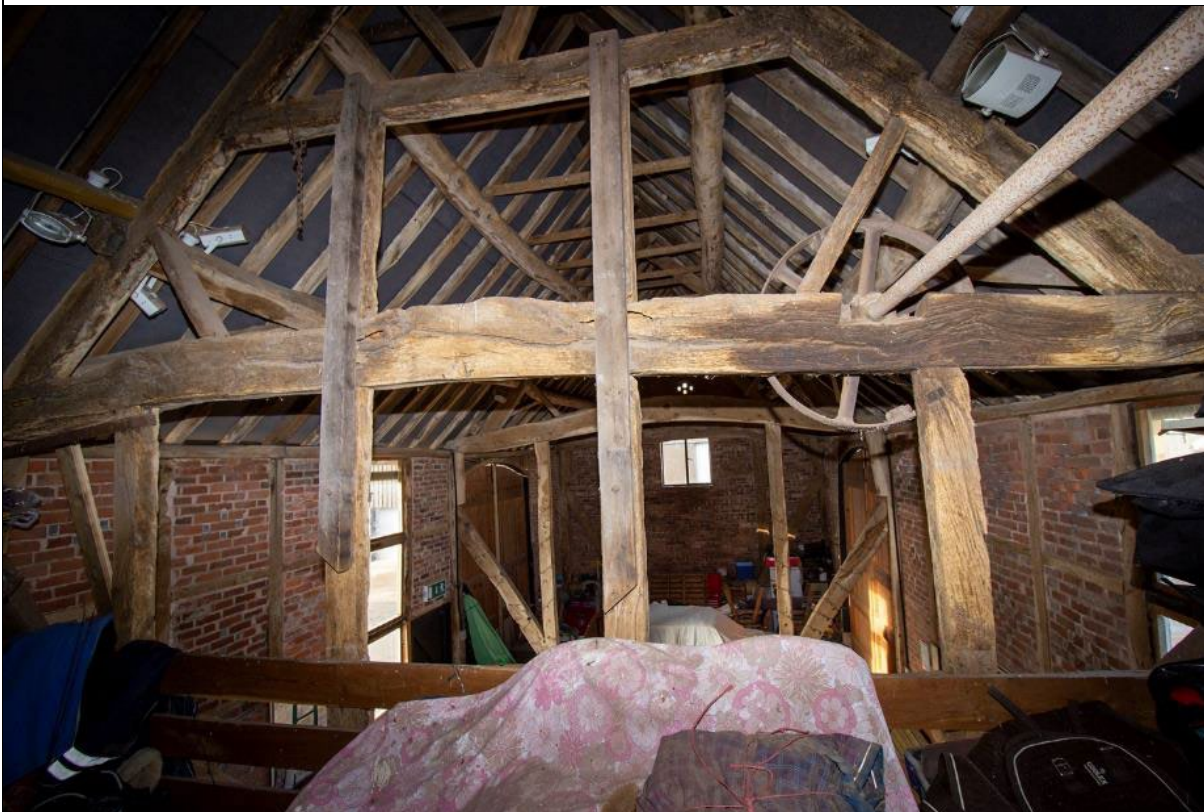
The interior of the threshing barn range, showing the flywheel and drive shaft from a mobile steam engine which powered threshing and fodder-processing machinery inside the barn. © Peter Gaskell/CCRI

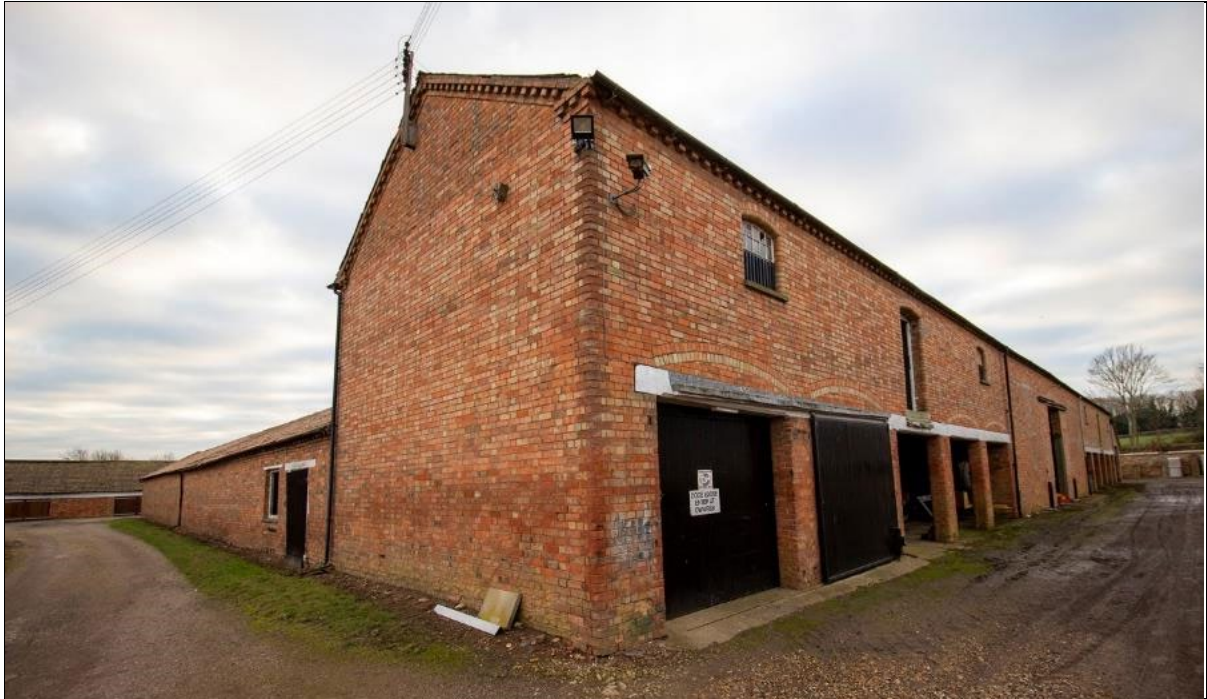
Part of an E plan multi-functional range with cart sheds, granaries and a large central threshing barn. © Peter Gaskell/CCRI

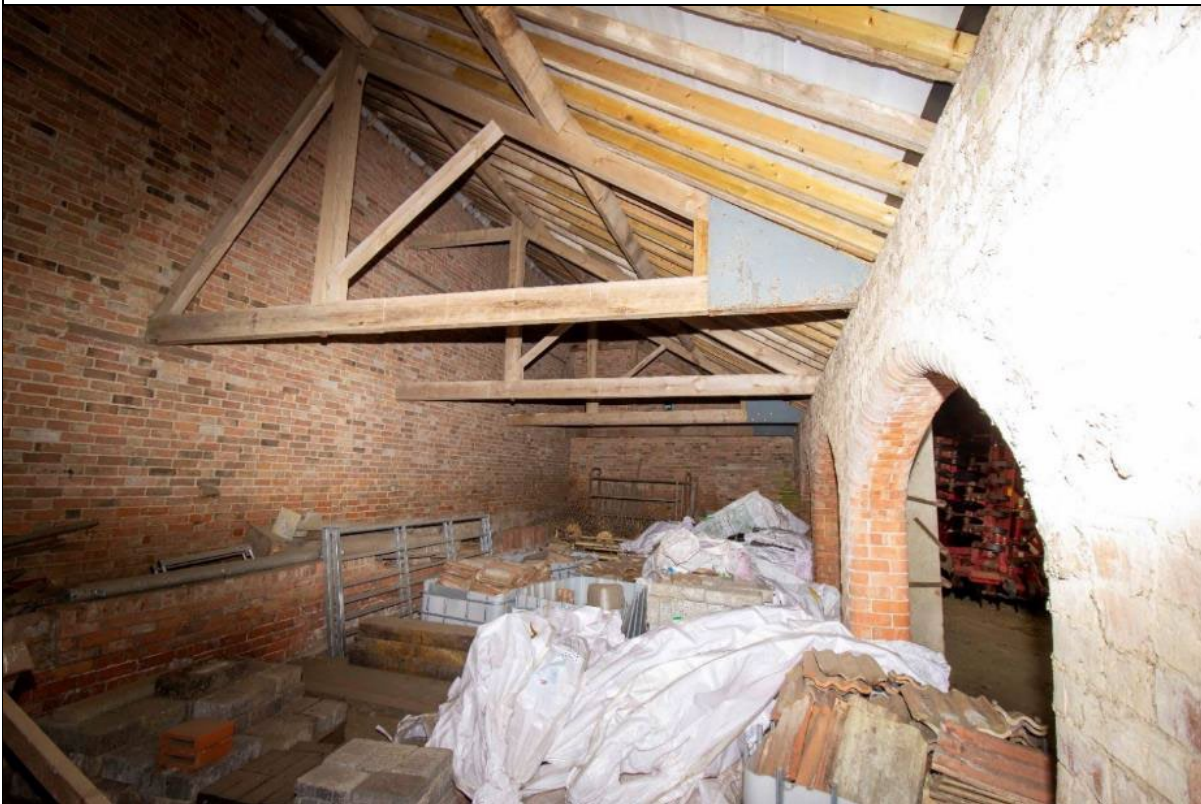
Roof repairs. © Peter Gaskell/CCRI

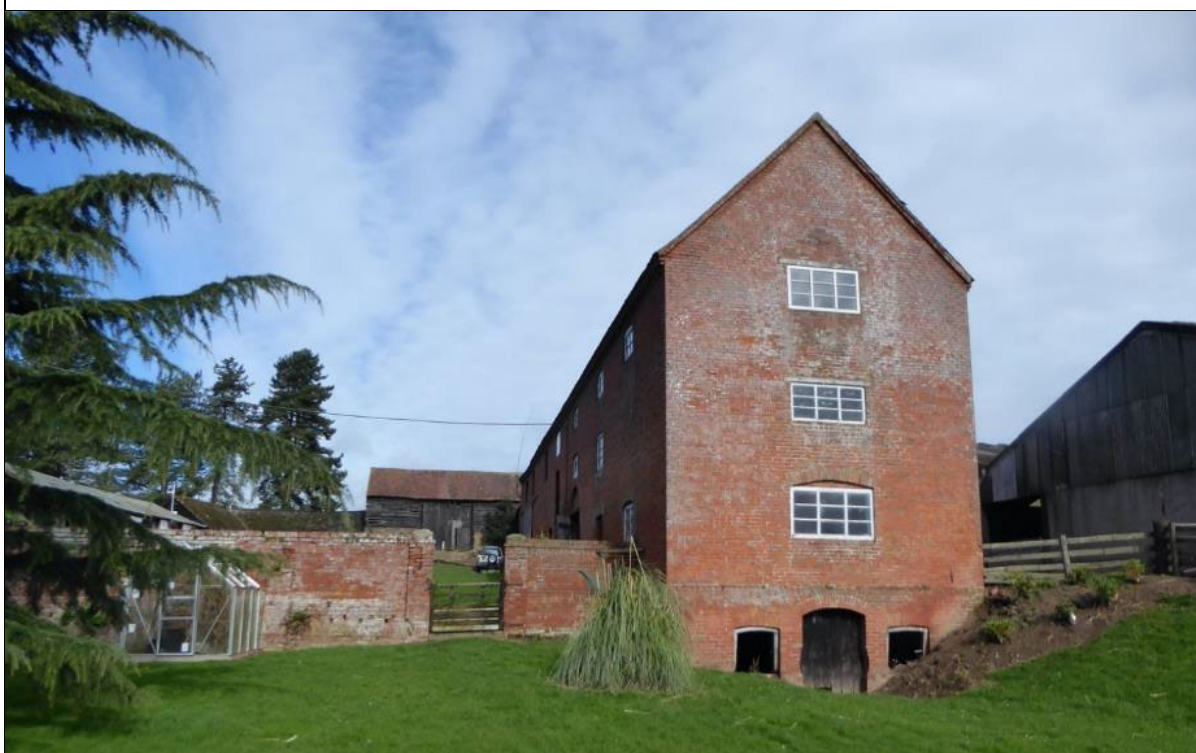
One of the large brick ranges on this farm. This range has a cellar for cider barrels below the cider mill and a kiln for drying hops. © Jeremy Lake/CCRI
