LUNDY: AN ANALYSIS AND COMPARATIVE STUDY OF FACTORS
AFFECTING THE DEVELOPMENT OF THE ISLAND FROM 1577 TO 1969,
WITH A GAZETTEER OF SITES AND MONUMENTS

VOL.2

GAZETTEER OF SITES AND MONUMENTS

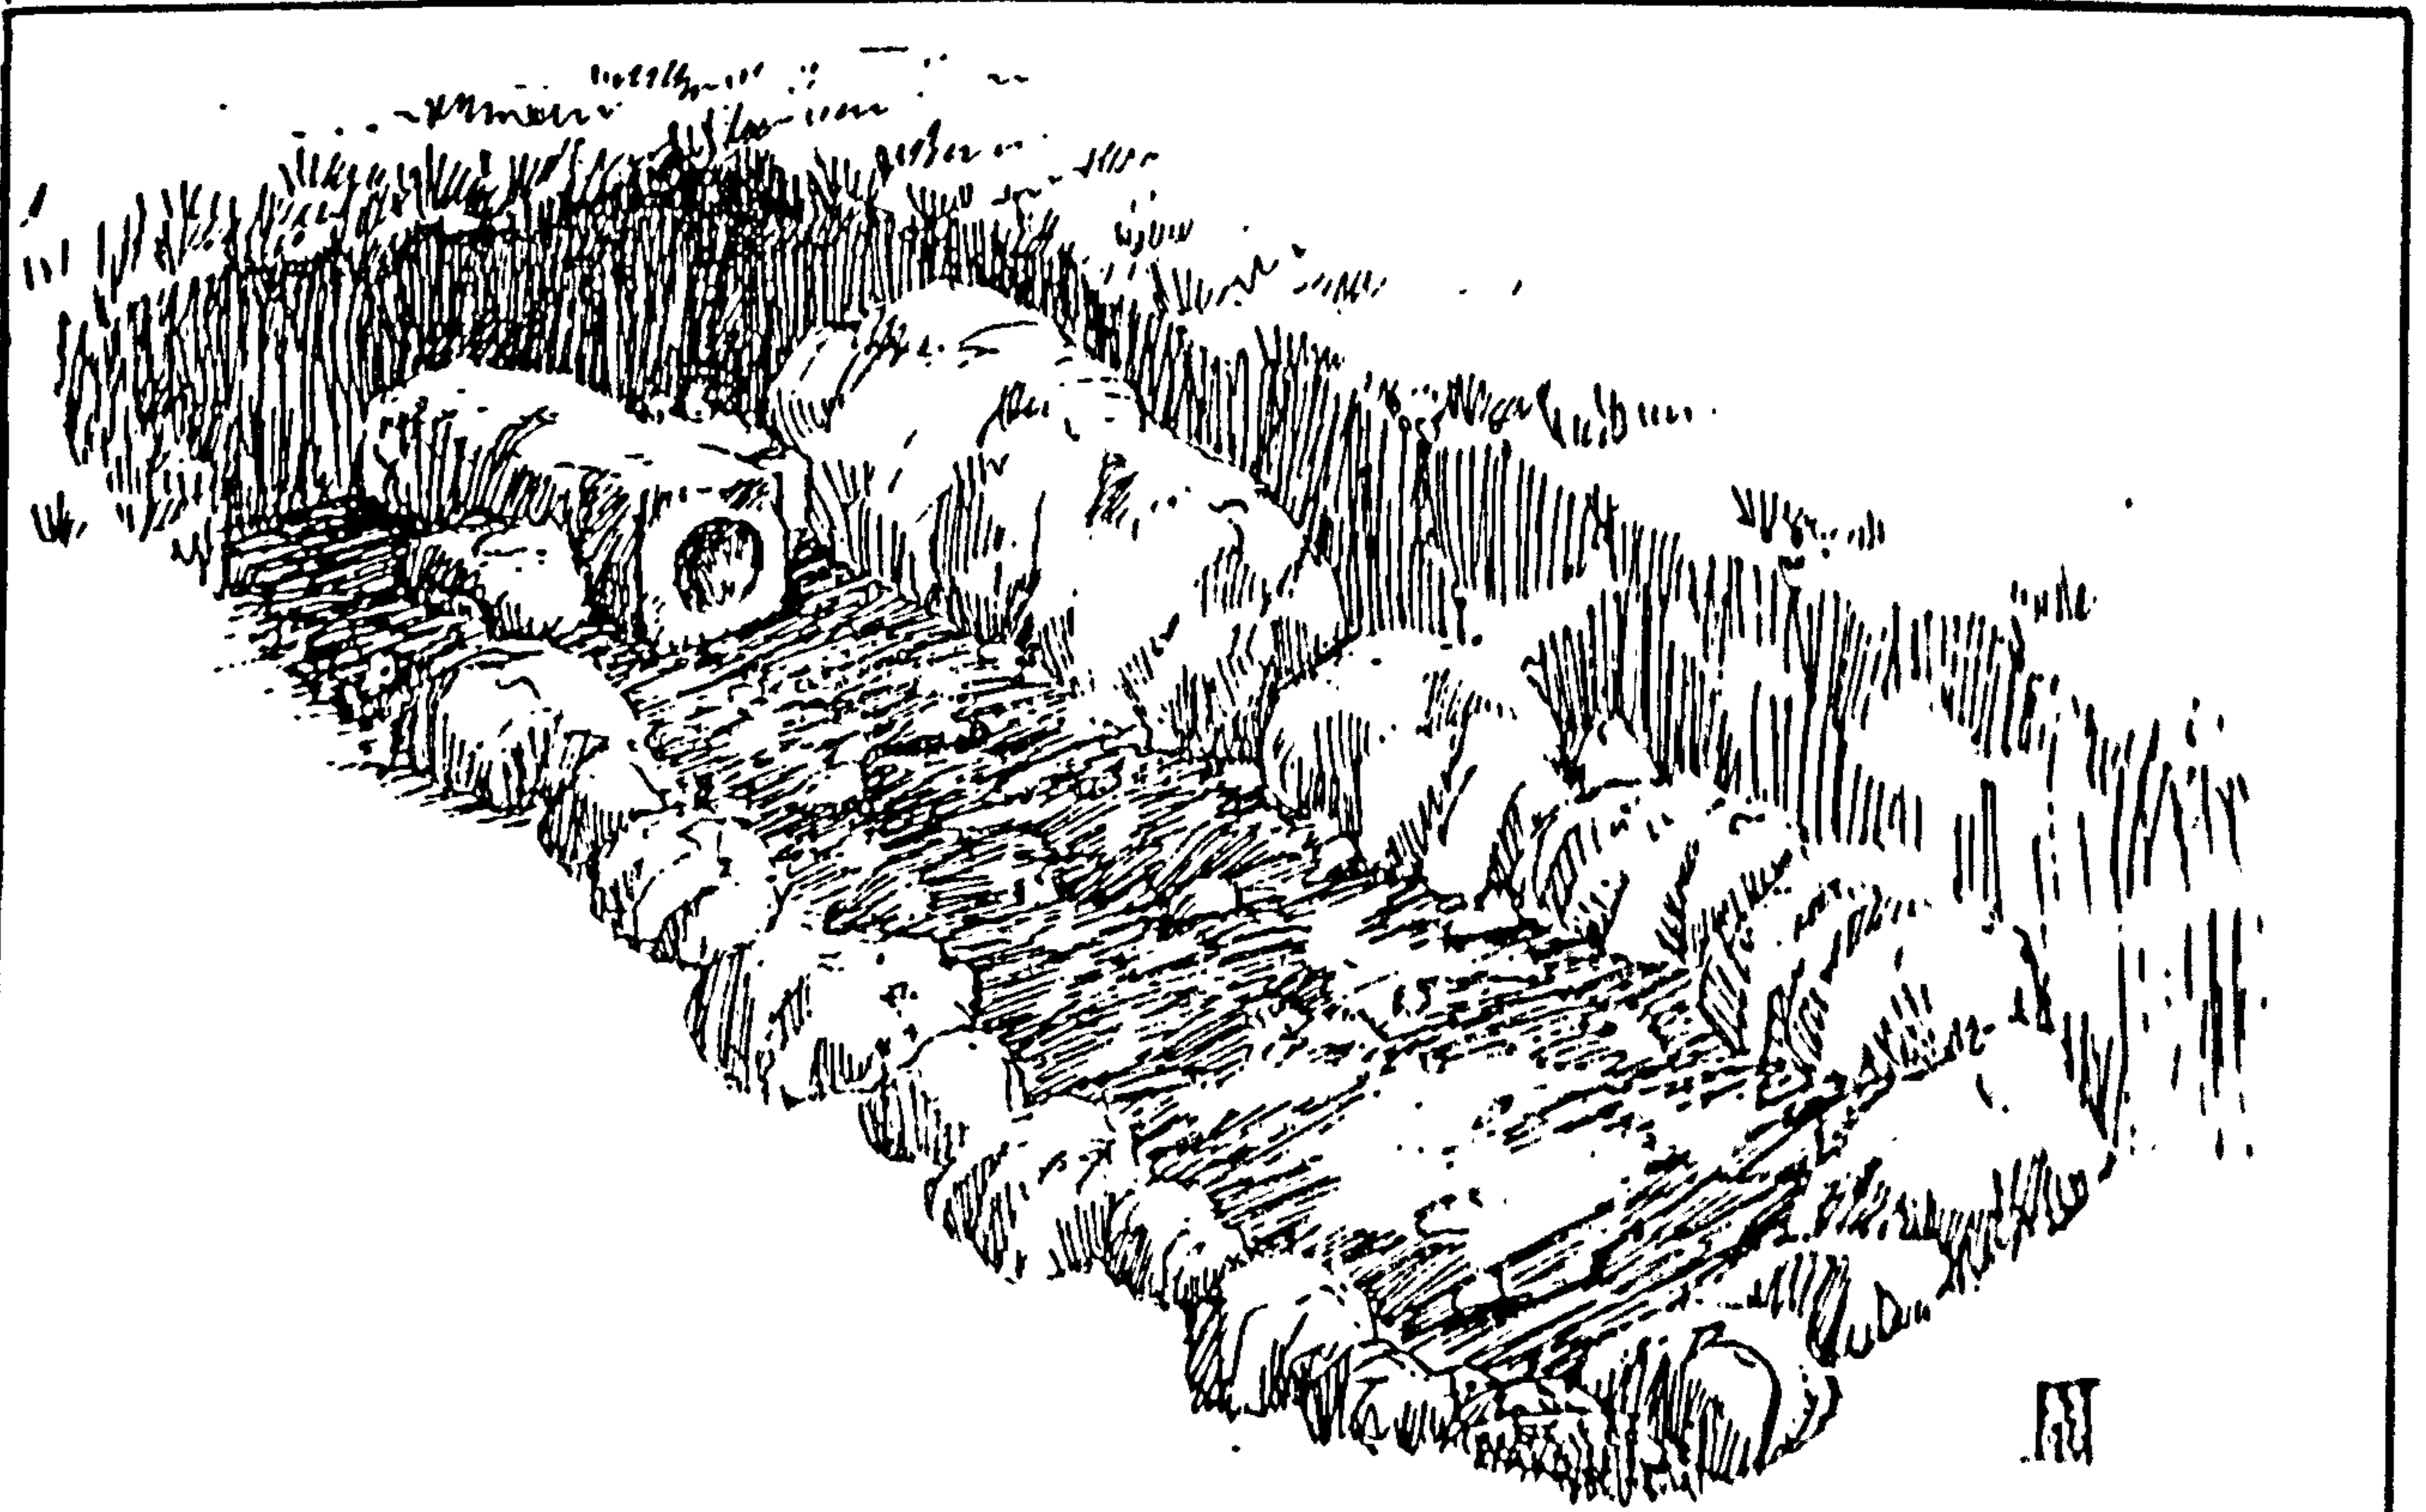
FIG. 3. *Reconstruction drawing of grave by Peter Rothwell*

The Giant's Grave (G269)
Gardner & Ternstrom, 1977, p.55.

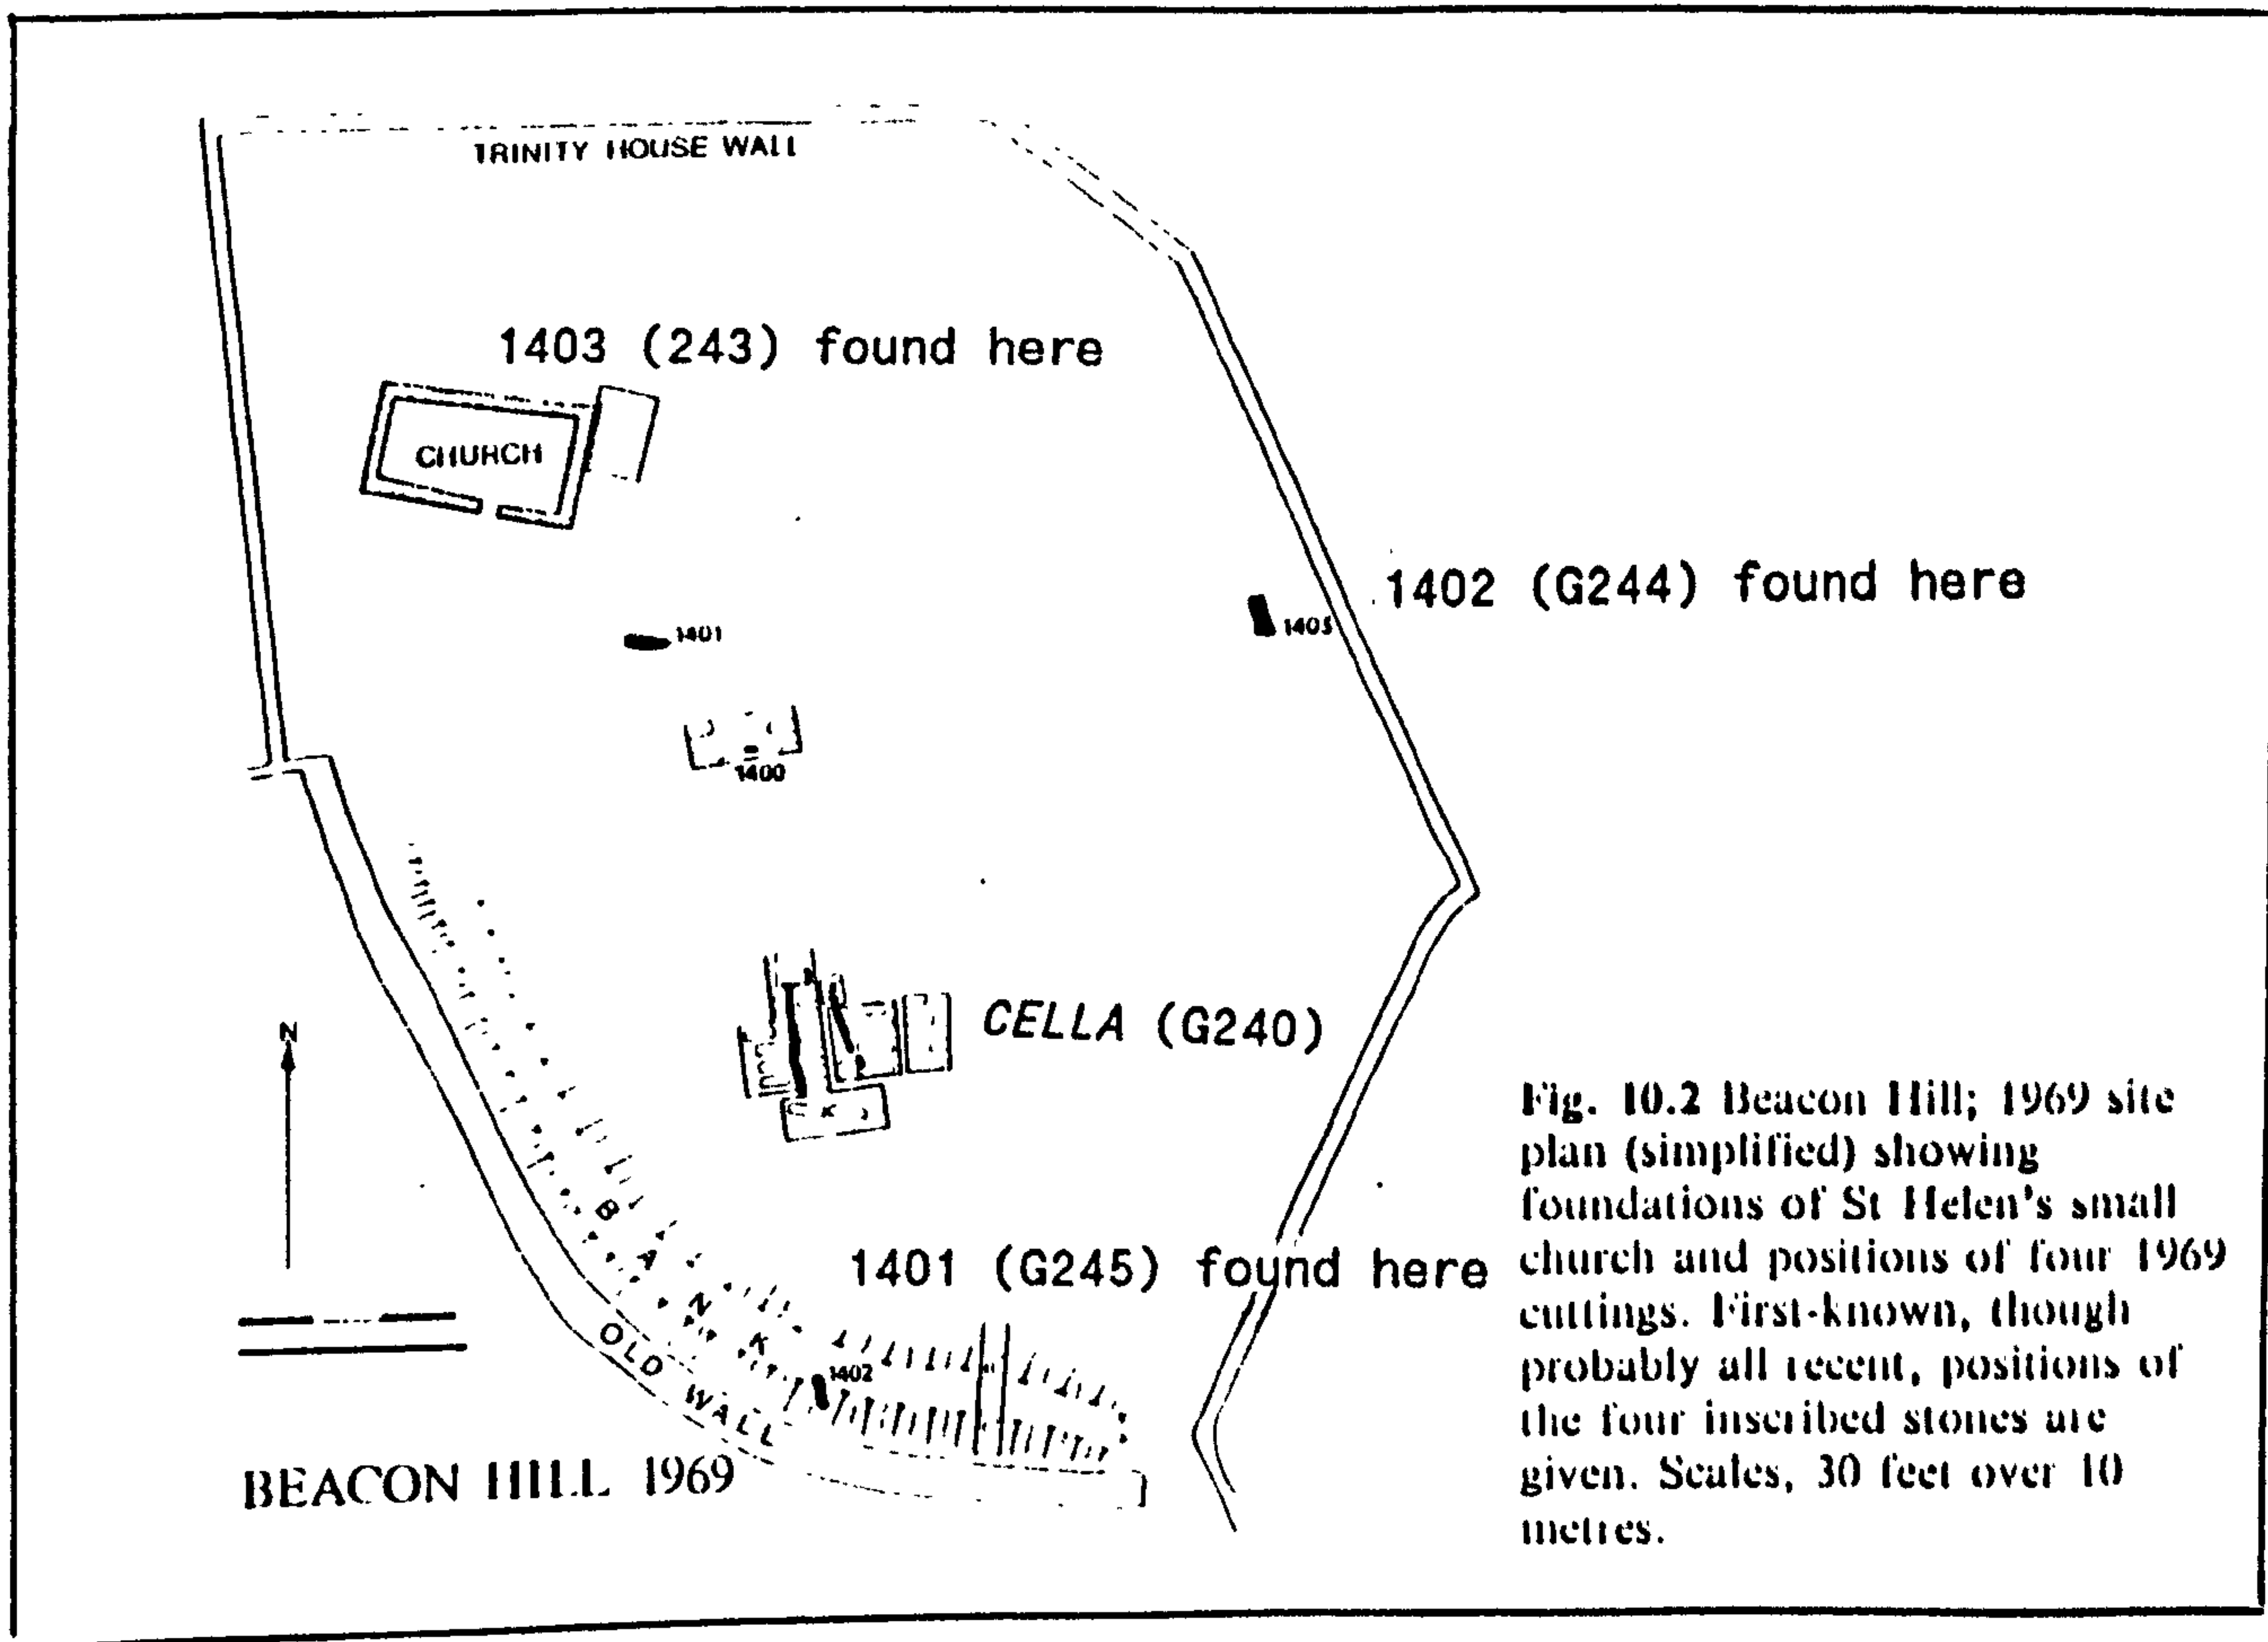
Fig. 10.2 Beacon Hill; 1969 site plan (simplified) showing foundations of St Helen's small church and positions of four 1969 cuttings. First-known, though probably all recent, positions of the four inscribed stones are given. Scales, 30 feet over 10 metres.

The entrance to the chapel is at N.

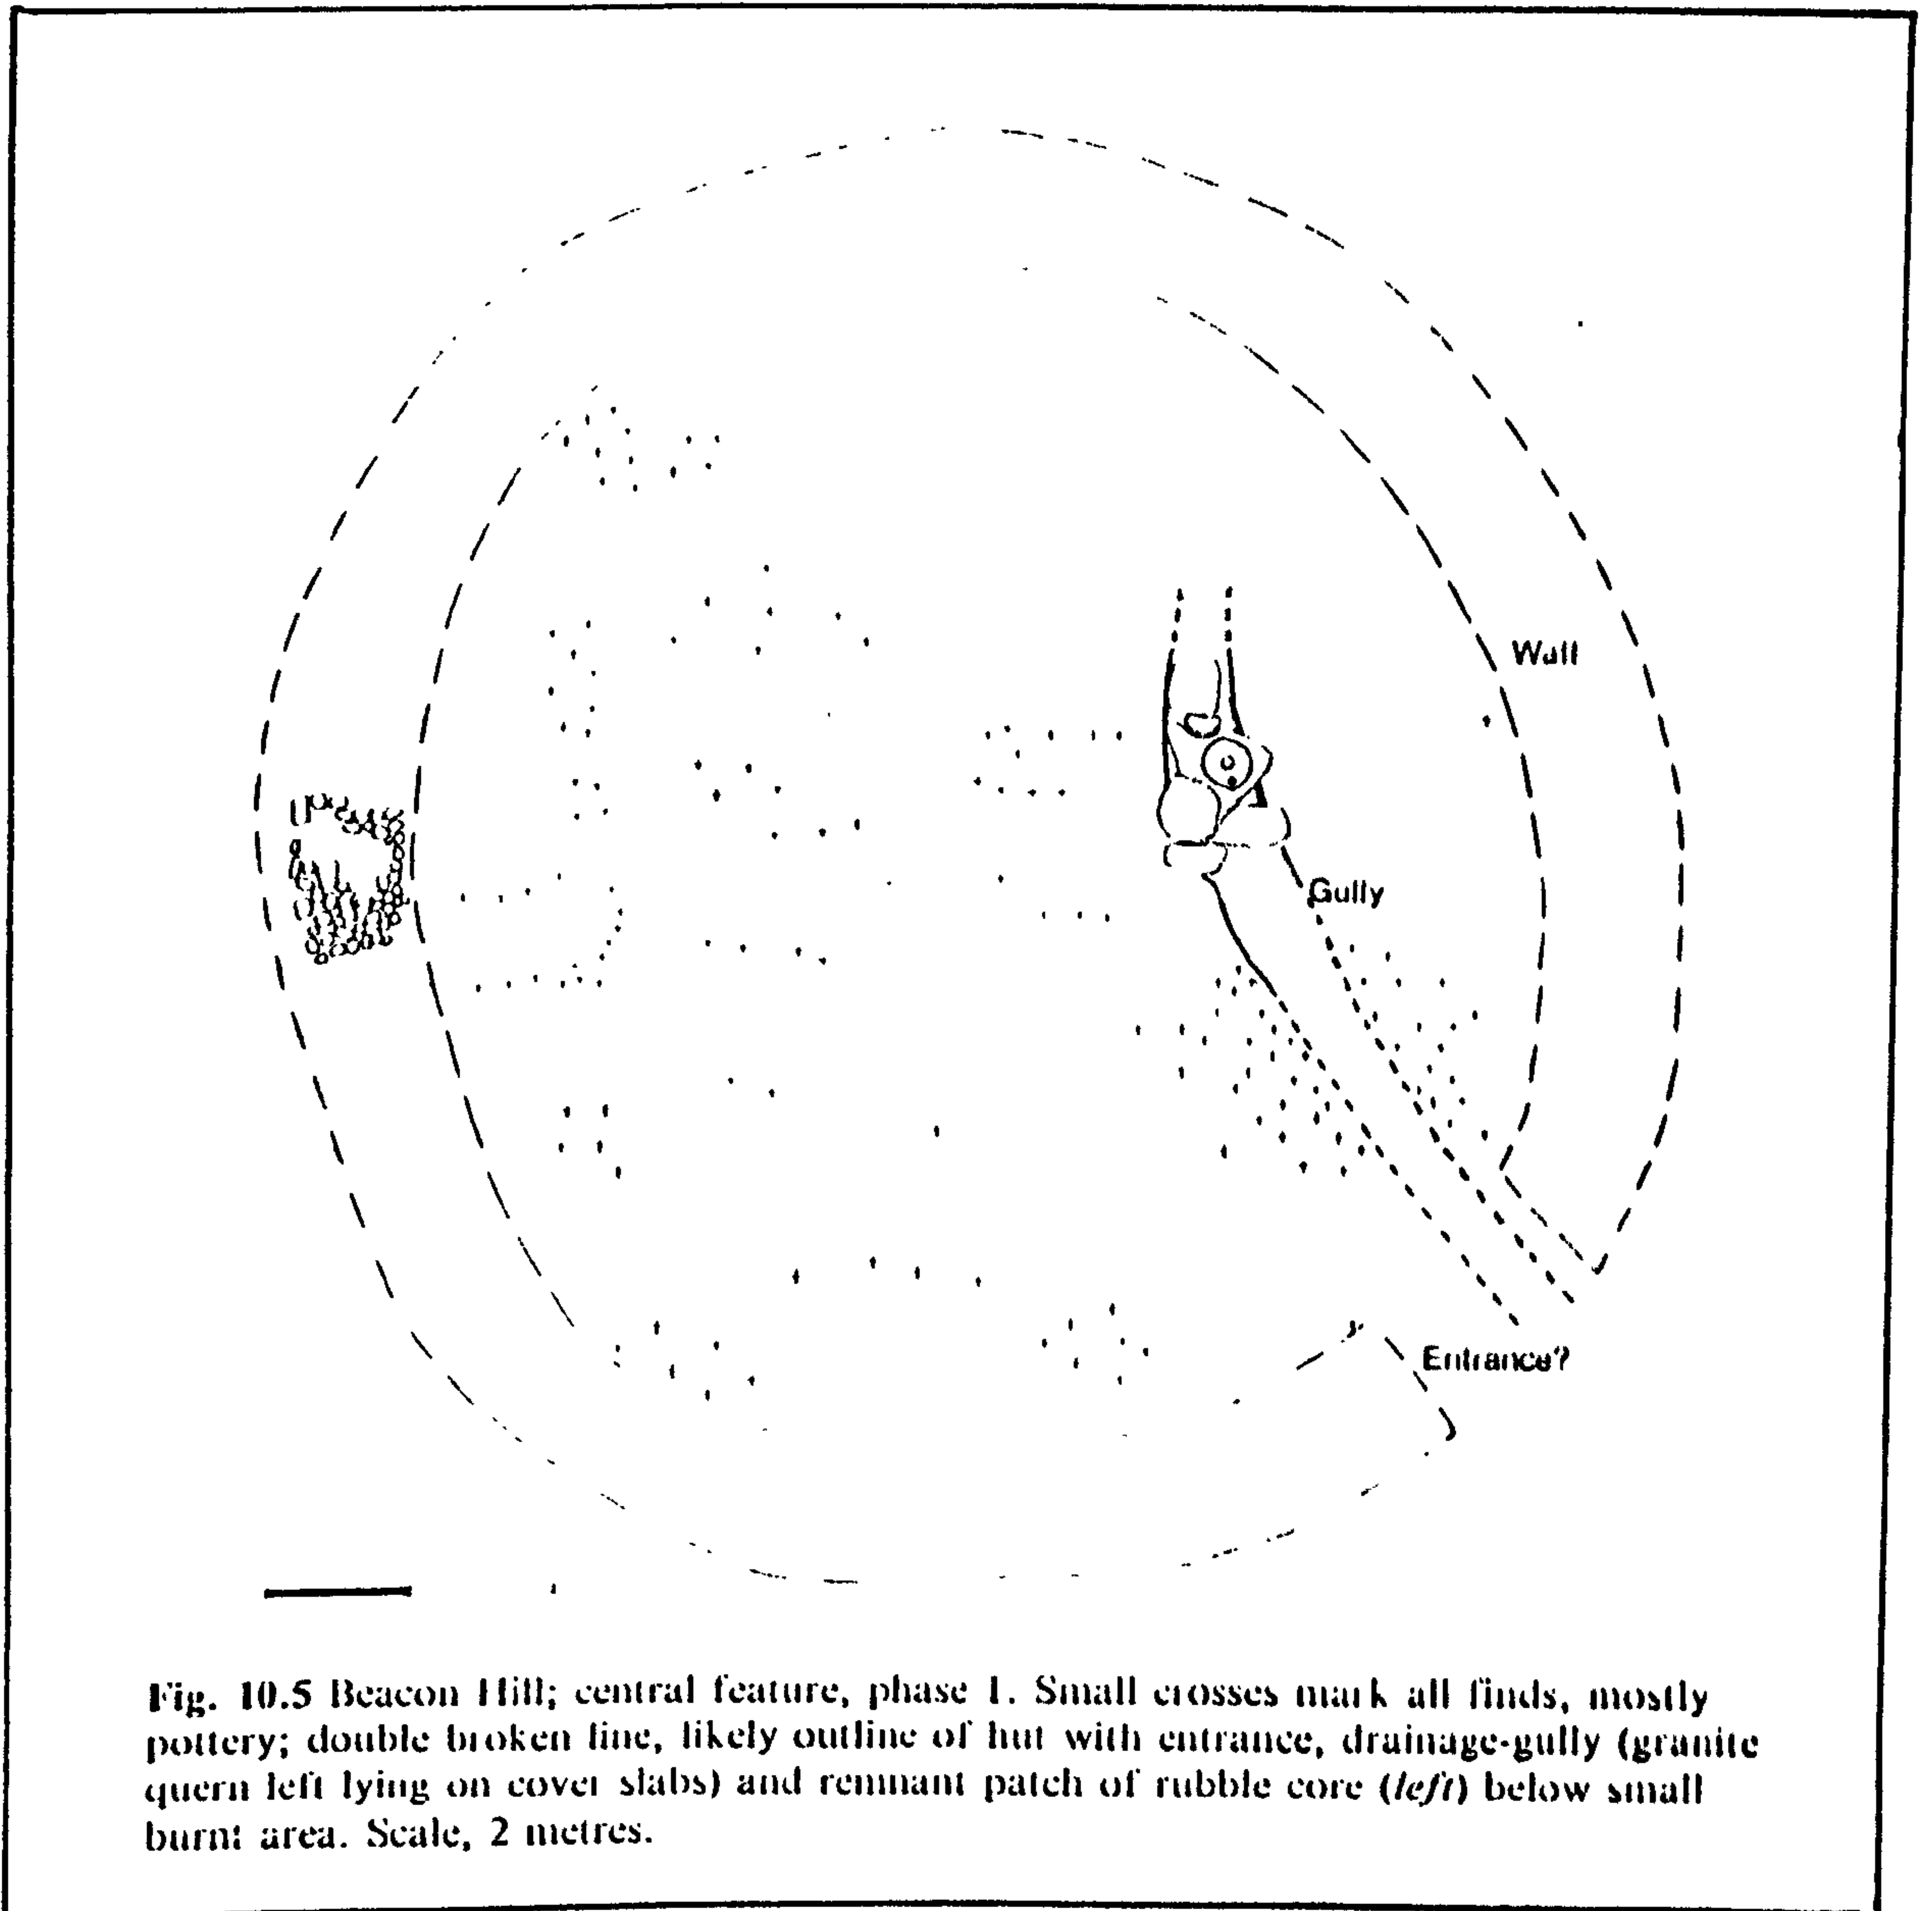
Romano-British hut (G239). Thomas, 1994, p.169.

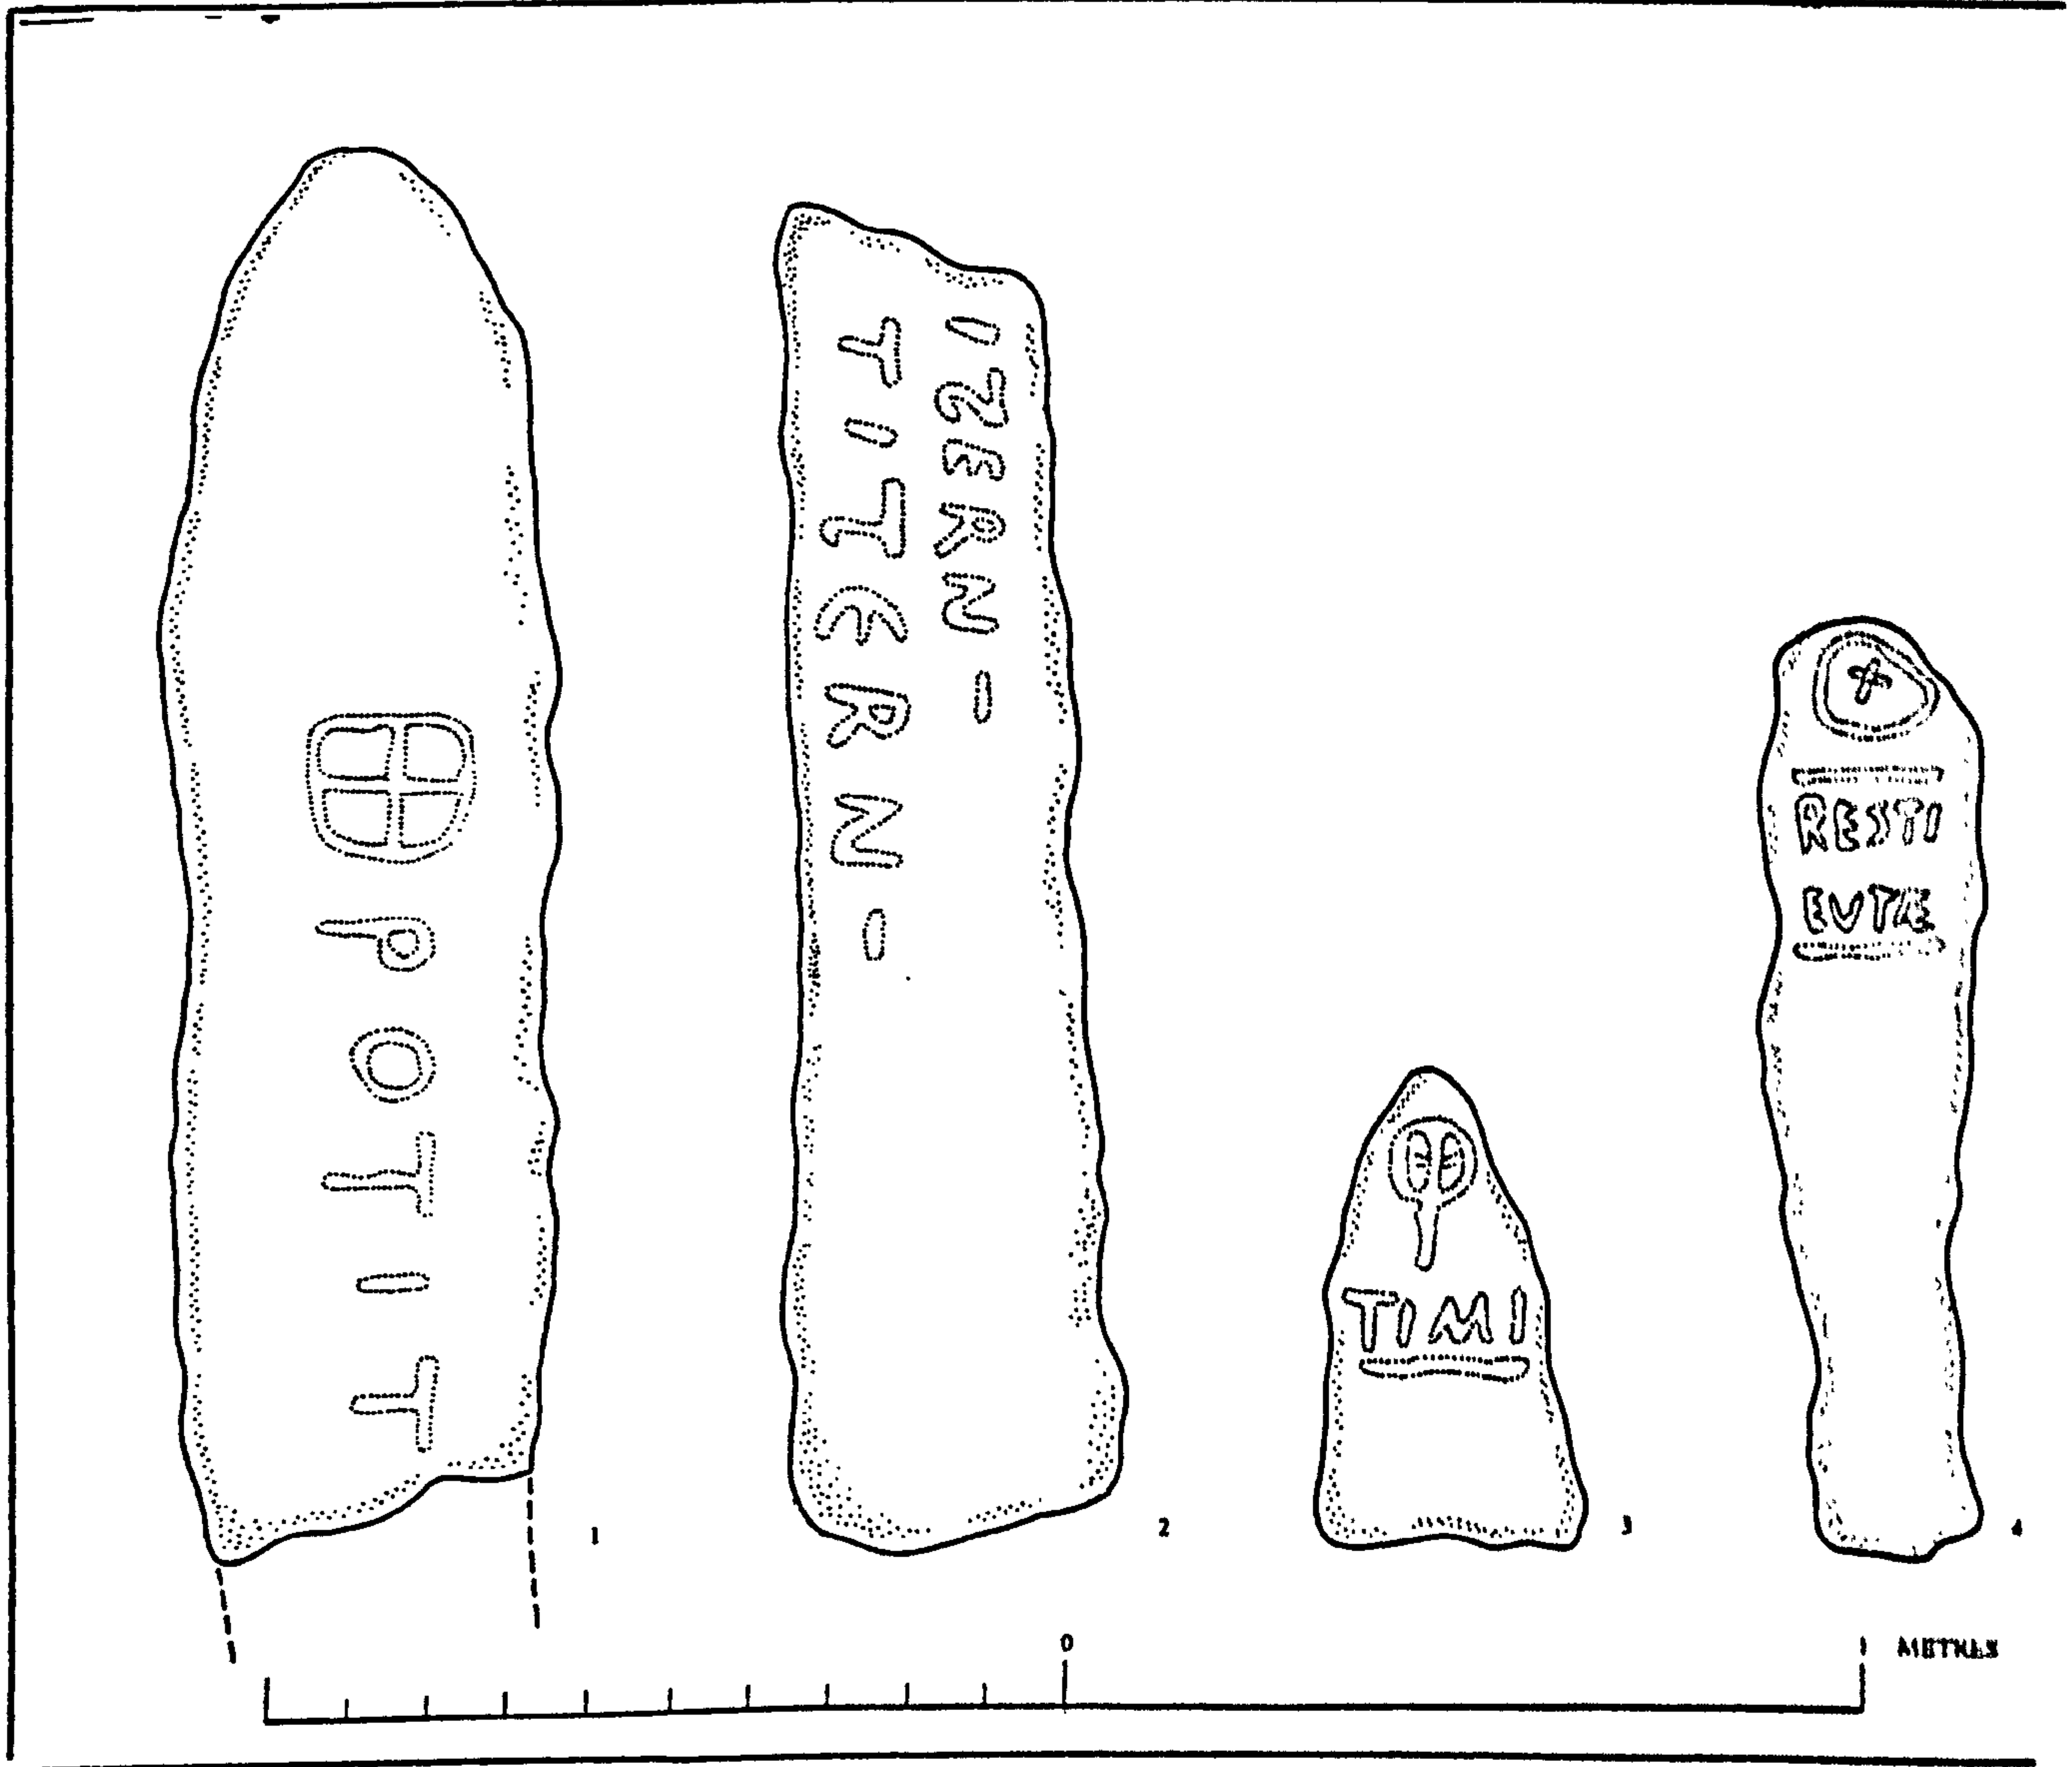
Inscribed stones, Beacon Hill (G243-G246). Langham, 1994, p.4

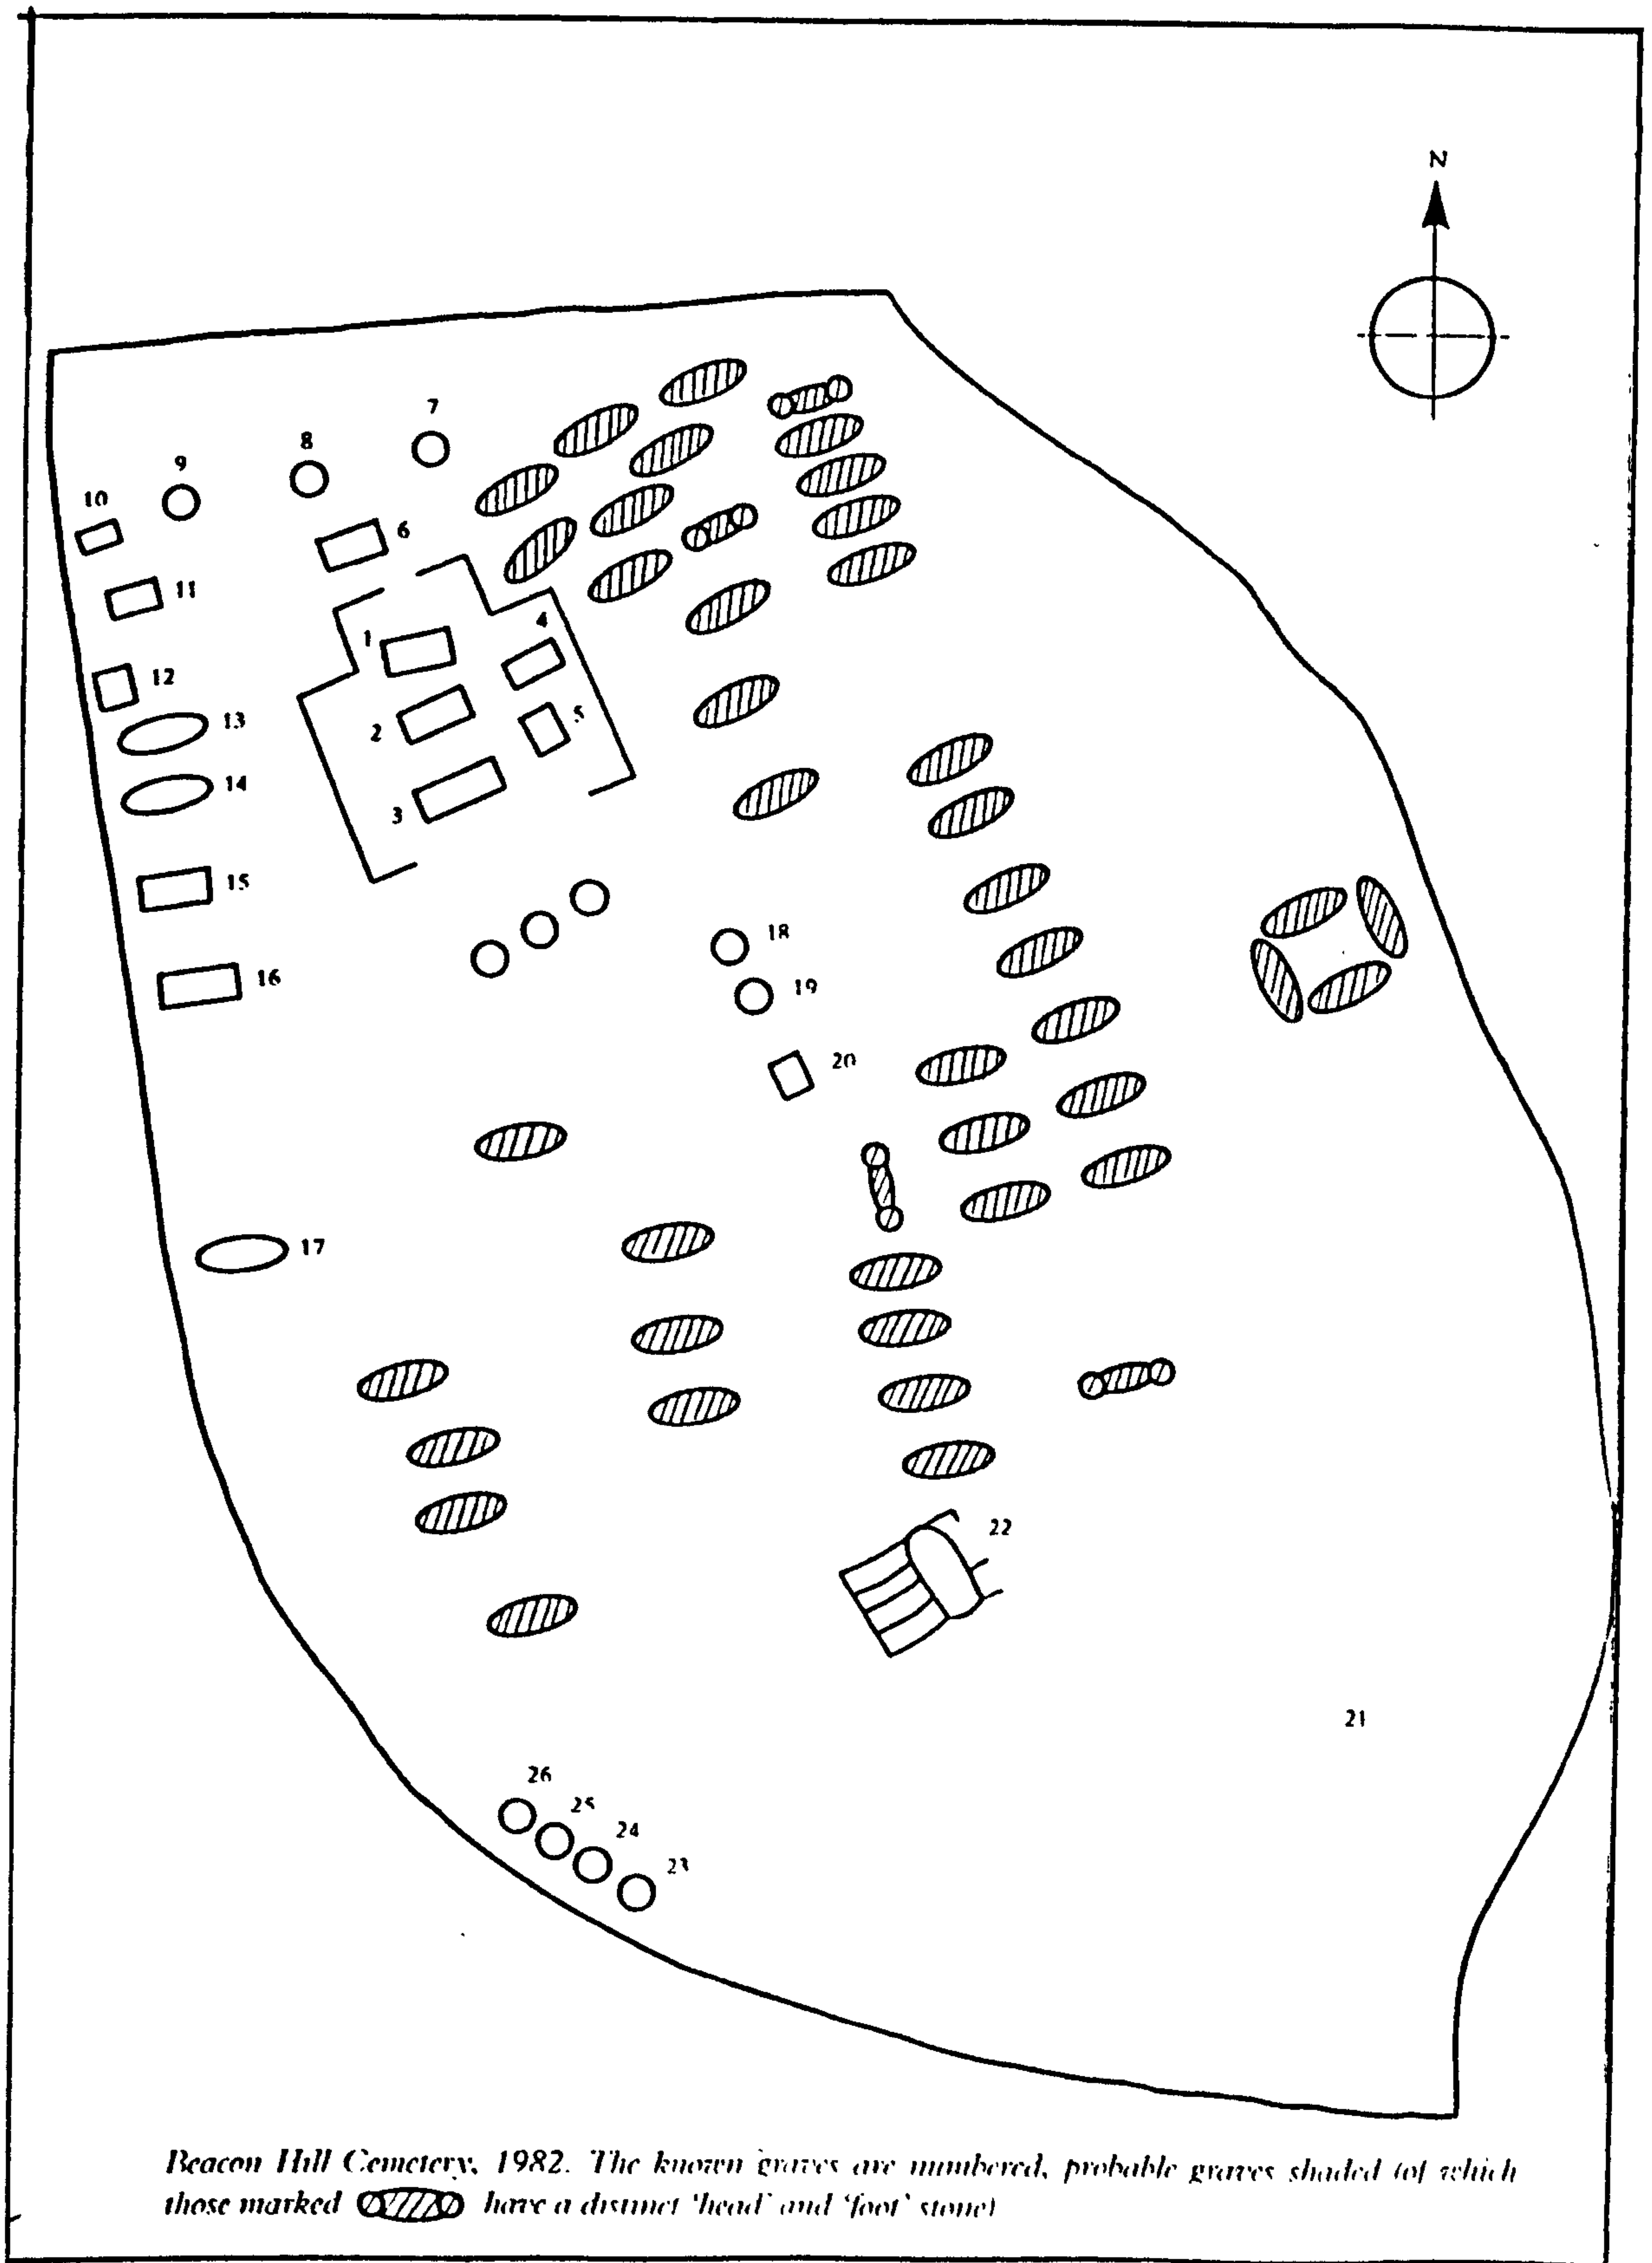
Langham, 1994, pp.104-105. Modern burials (G248).
 The configuration of the chapel is inaccurate.

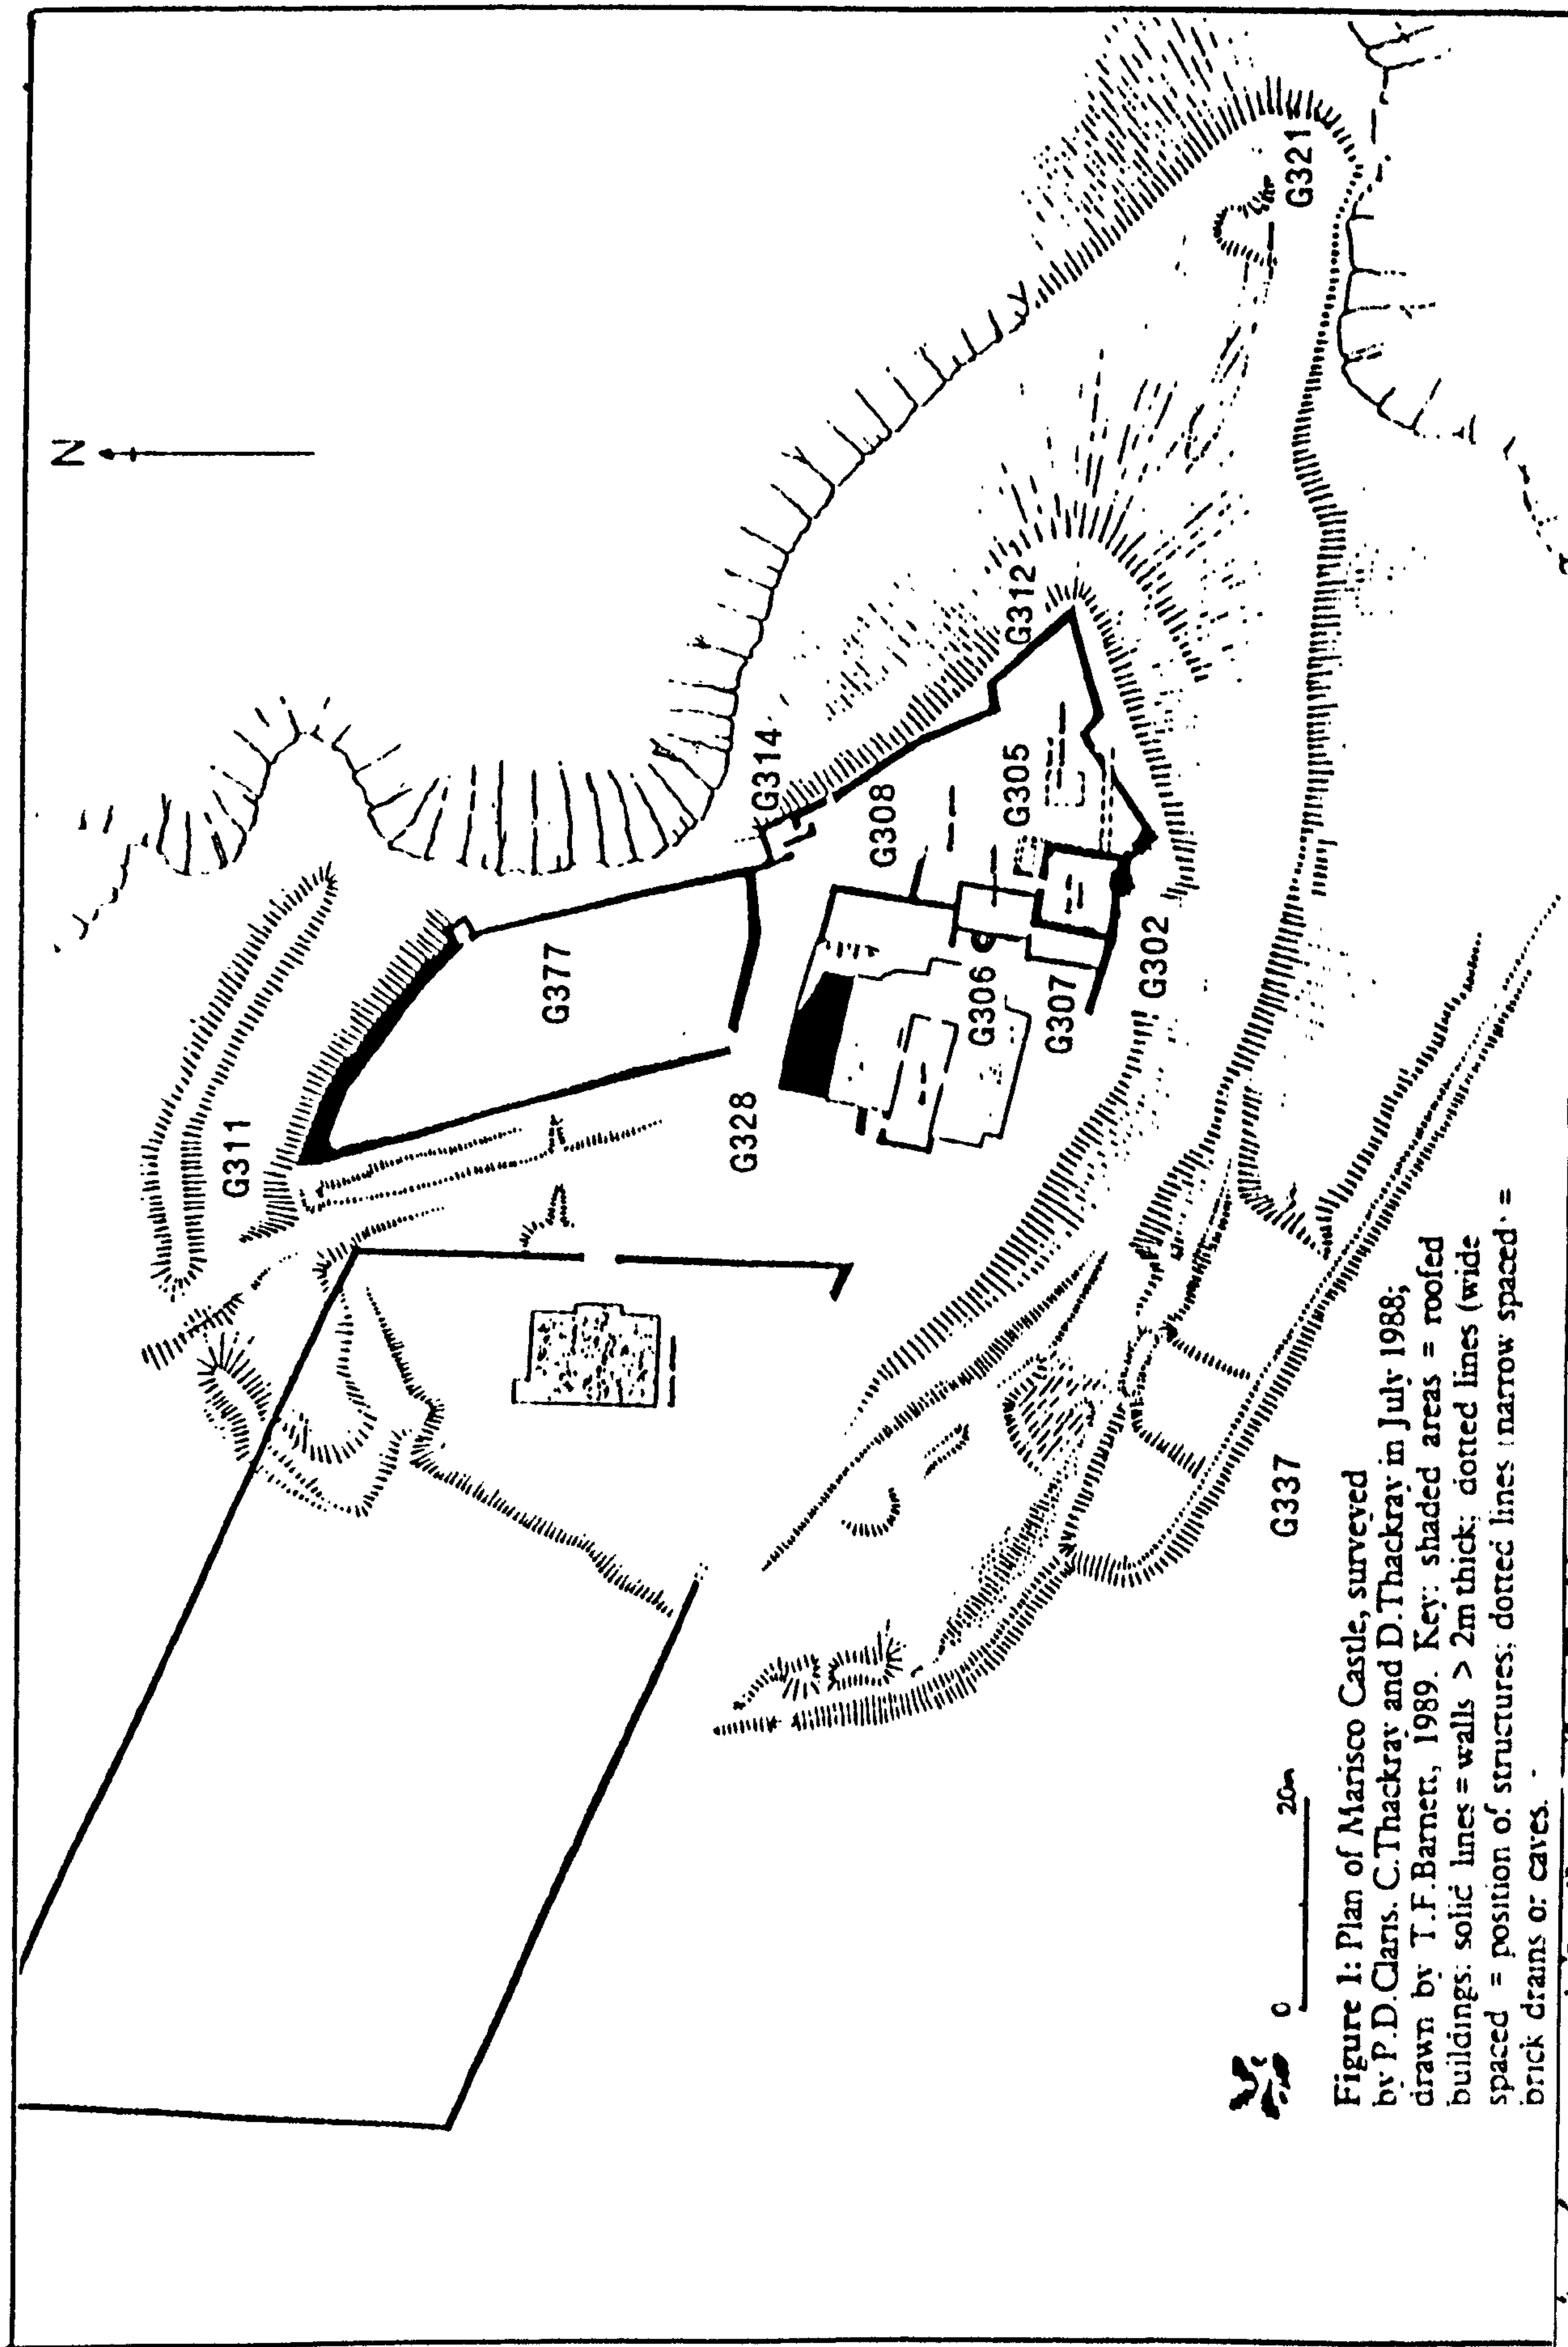
Figure 1: Plan of Marisco Castle, surveyed by P.D. Claris. C.Thackray and D.Thackray in July 1988; drawn by T.F. Barnett, 1989. Key: shaded areas = roofed buildings; solid lines = walls > 2m thick; dotted lines (wide spaced) = position of structures; dotted lines (narrow spaced) = brick drains or caves.
